# Operation UPSHOT-KNOTHOLE

Project 3.29

BLAST EFFECTS OF ATOMIC WEAPONS  
UPON CURTAIN WALLS AND PARTITIONS  
OF MASONRY AND OTHER MATERIALS

Issuance Date: April 21, 1959

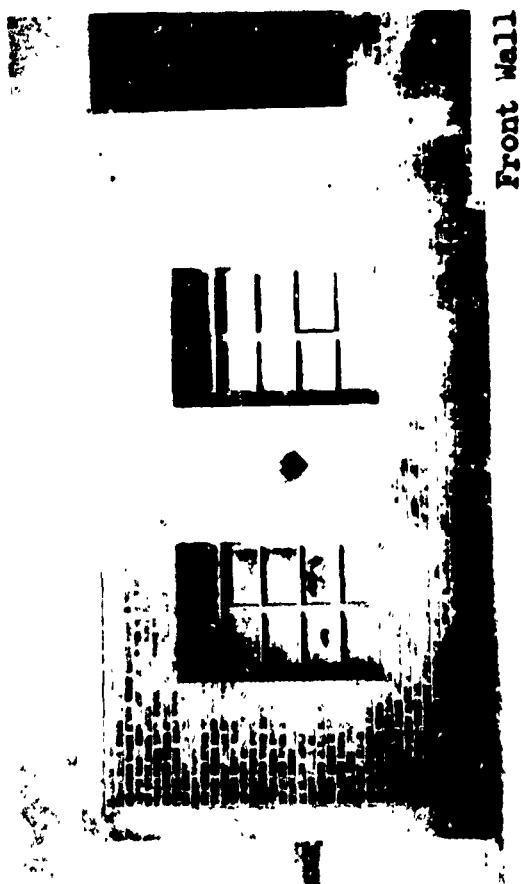
Front Wall

The front wall was spalled at the top on the outside face. The window frames were bowed in slightly at the cross rail.

The rear wall was marked on the inside face and spalled on the outside face at the top, north edge.

The measured, pre shot, natural frequency of the front wall was 36.1 cps. For the rear wall, the measured, pre shot and post shot, natural frequencies were 36.1 cps and 19.8 cps, respectively.

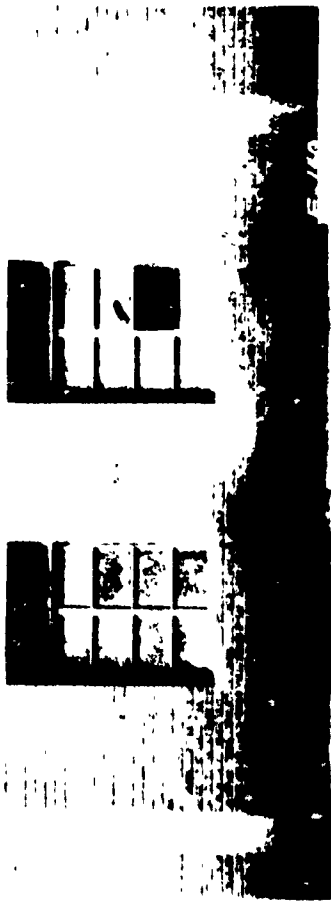
Front Wall

The front wall was bowed out 1/2 in. at the top above the north window. The outside face was spalled at the top edge. The windows were bowed in slightly. The inside face had a horizontal crack in the center section 3 joints above the sills.

The rear wall was spalled at the top edge on the outside face.

The measured, pre shot and post shot, natural frequencies of the front wall were 33.4 cps and 20.6 cps, respectively. For the rear wall, the measured, pre shot and post shot, natural frequencies were 58.3 cps and 31.2 cps, respectively.

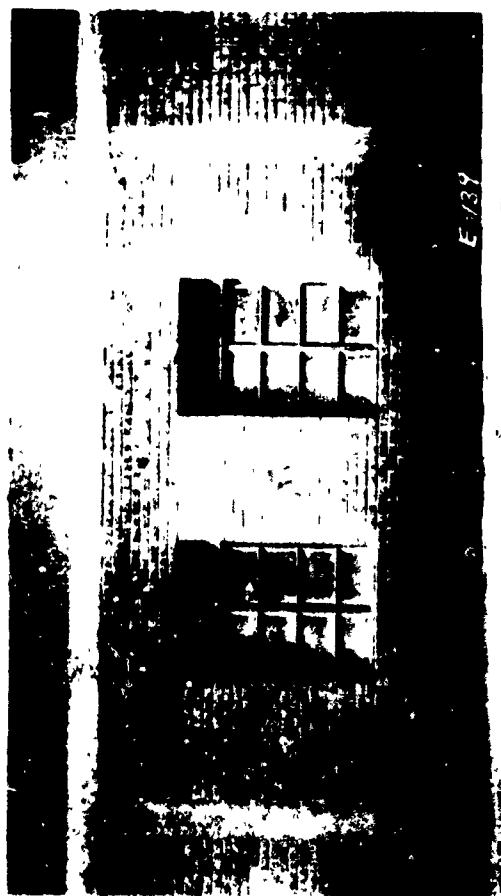
Front Wall

The partitions were blown over without much movement of the base and remained in one piece although bowed and cracked badly.

The front wall was spalled at the top, on the outside face, with the window frames bowed in slightly. The inside face had a horizontal crack in the center section, at the 4th mortar joint above the sill.

The rear wall was spalled badly, at the top, south side, on the outside face. The wall was bowed out at the top from nothing at the north edge to 1 in. at the south edge. There was a vertical crack from the top to the center at the south 1/4 point on the outside face. The inside face was covered by the partitions.

The measured, pre shot and post shot, natural frequencies of the front wall were 33.3 cps and 25.0 cps, respectively. For the rear wall, the measured, pre shot and post shot, natural frequencies were 55.3 cps and 12.7 cps, respectively.

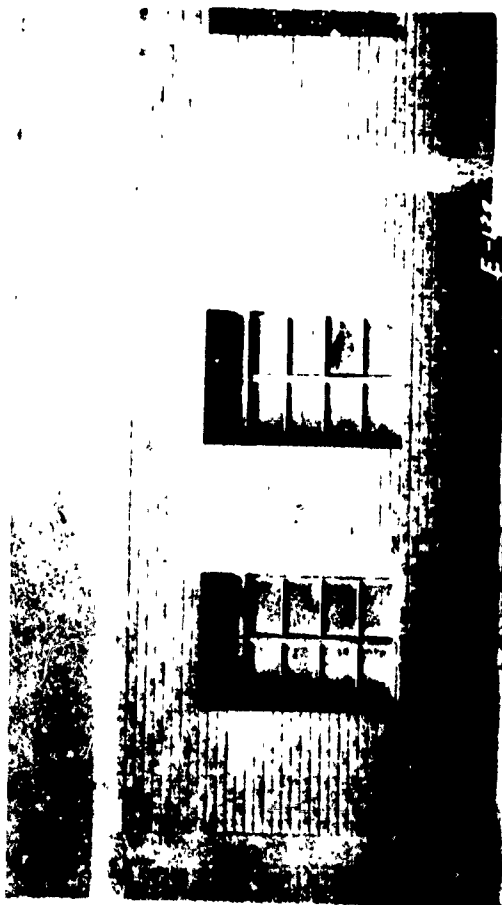
Front Wall

The front wall was spalled at the top on the outside face.

The rear wall was slightly spalled at the top on the outside face. The inside face was covered by the partitions.

The measured, pre shot and post shot, natural frequencies of the front wall were 34.2 cps and 21.9 cps, respectively. For the rear wall, the measured, pre shot and post shot, natural frequencies were 41.1 cps and 31.5 cps, respectively.

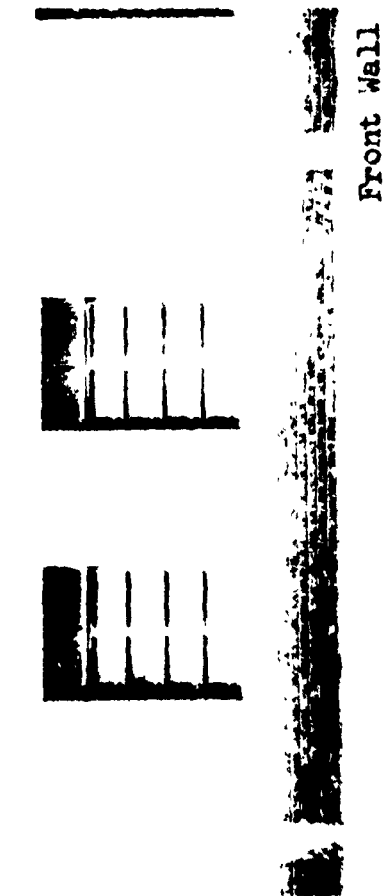
The front wall was slightly spalled at the top on the outside face. The window frames were bowed in.

The rear wall was slightly spalled at the top on the outside face.

The measured, pre shot and post shot, natural frequencies of the front wall were 38.4 cps and 21.8 cps, respectively. For the rear wall, the measured, pre shot and post shot, natural frequencies were 47.1 cps and 24.0 cps respectively.

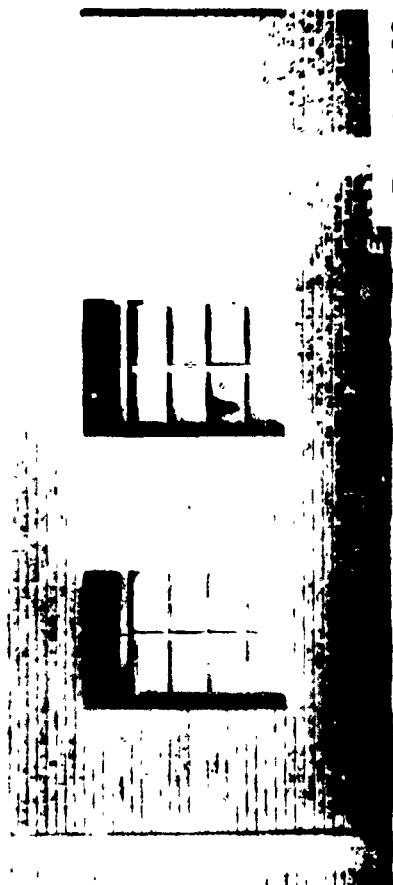
Front Wall

The south section of the front partition was destroyed except for fillets. The north section of the front partition was bowed slightly toward the front and cracked vertically at the center.

The measured, pre shot and post shot, natural frequencies of the rear wall were 37.5 cps and 29.7 cps, respectively.
